Unit A102

AS1

VACANT SPACE
(UNIT A102)

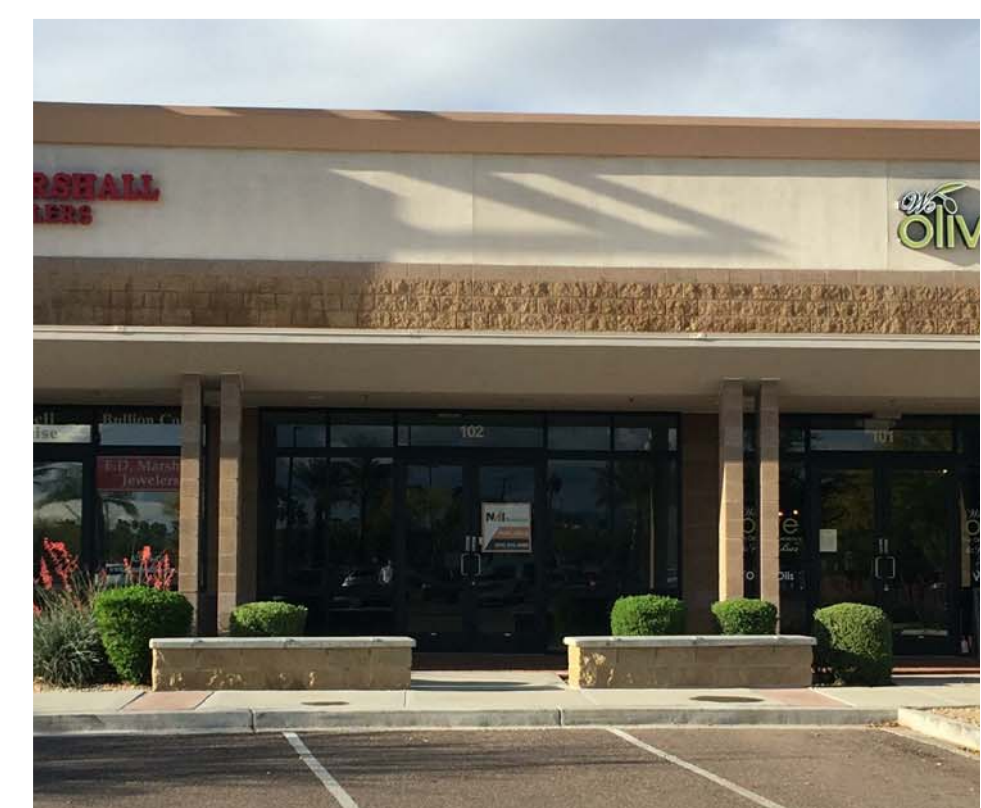
1 ELEVATION (PHOTO)
1/8" = 1'-0"

NOTE
01) STOREFRONT: DARK BRONZE/GLASS (GOOD CONDITION)

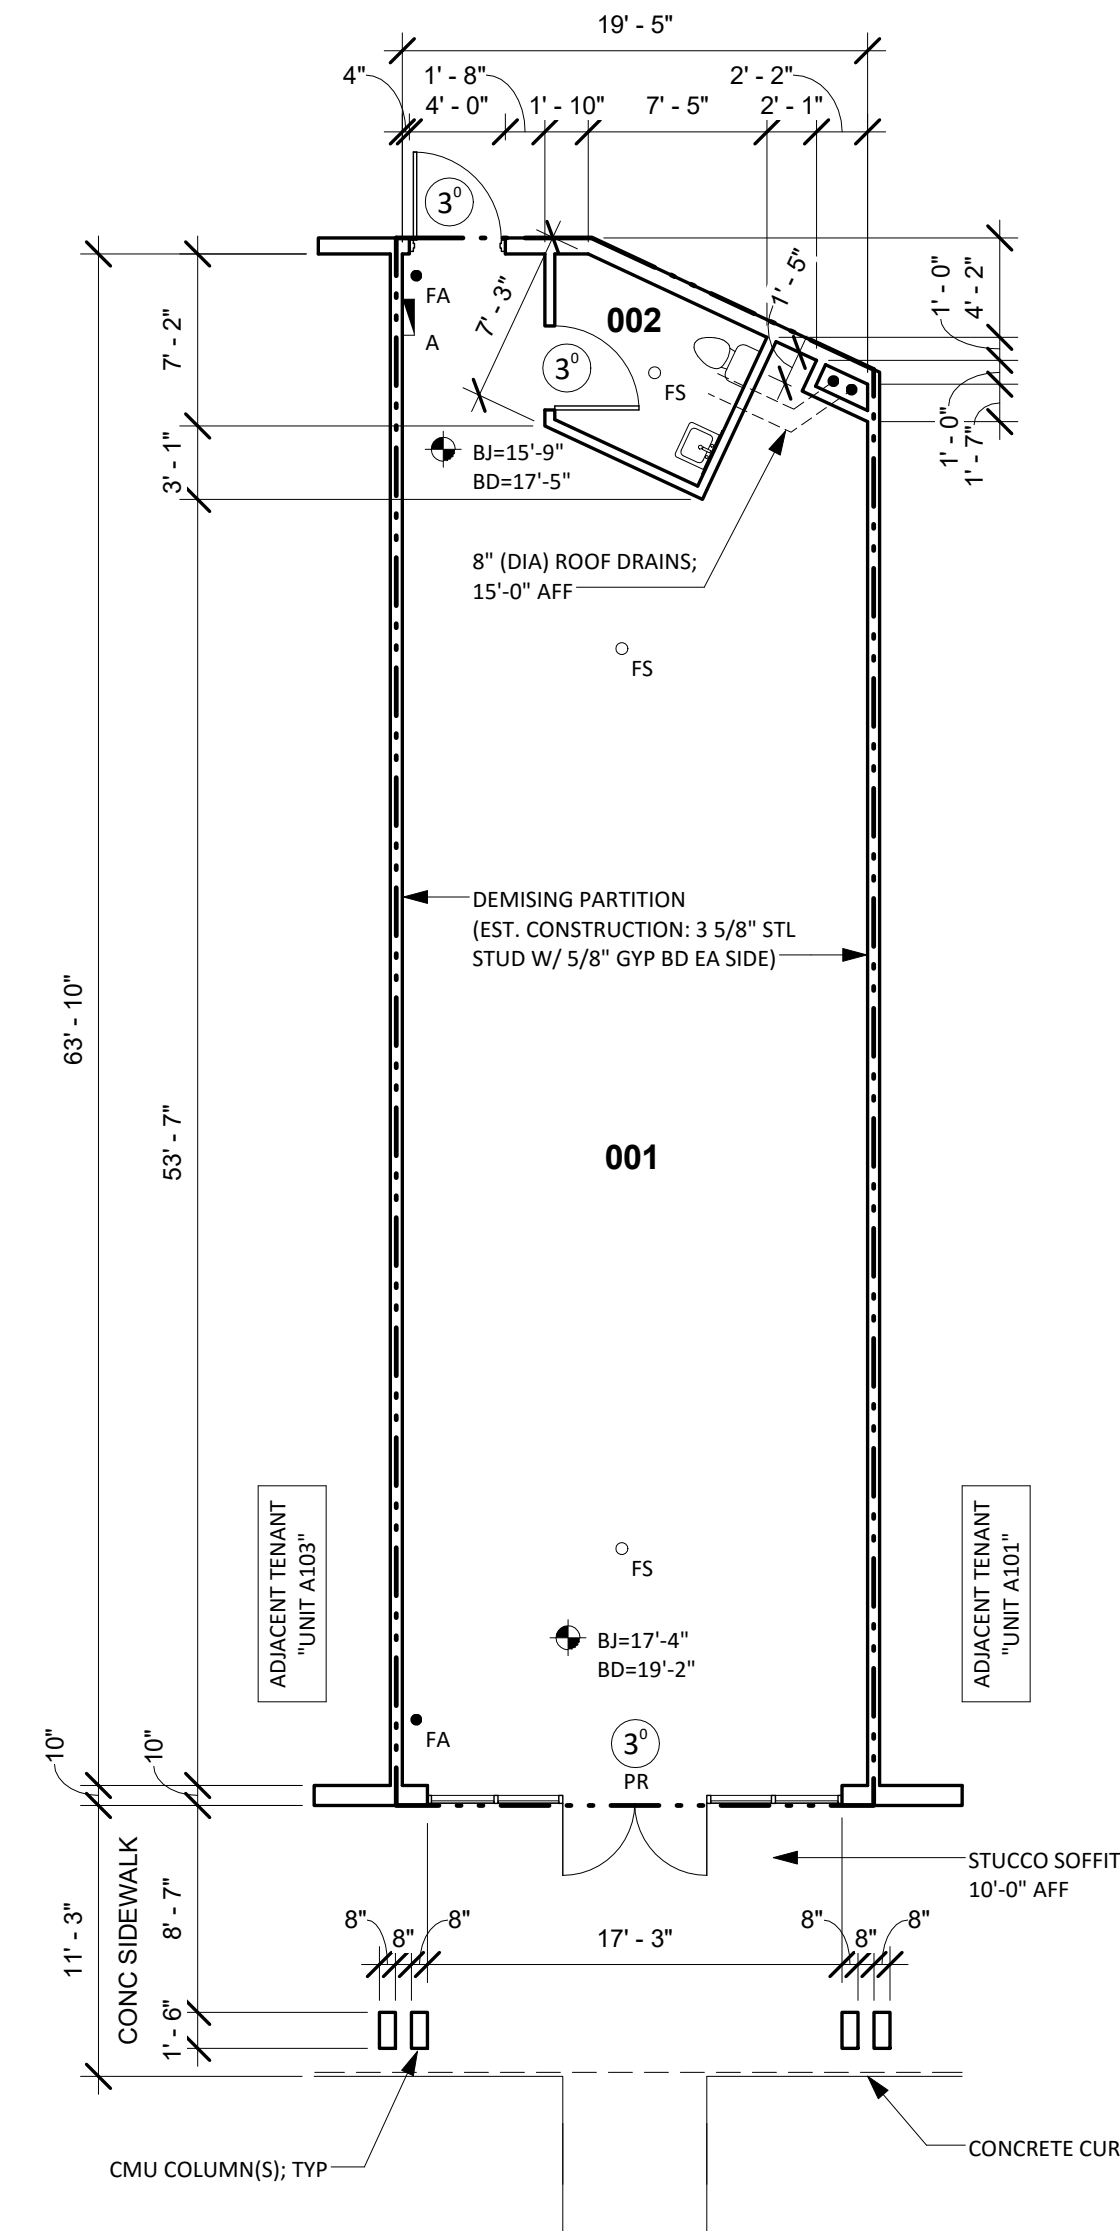
3 EXISTING FLOOR PLAN
1/8" = 1'-0"

ROOM	FLR MAT'L	FLR COND.	WALL MAT'L	WALL COND.	CLG MAT'L	CLG HGT	CLG COND.	ADD'L COMMENTS
001	EXPOSED CONC	GOOD	WALLBOARD	GOOD	ACT	10'-6"	GOOD	
002	LINOLIUM	FAIR	WALLBOARD (PTD)	GOOD	WALLBOARD (PTD)	8'-0"	GOOD	4'-6" FRP WAINSCOT / 4" COVED LINOLIUM
