6051

AS2

VACANT SPACE
(UNIT 12)

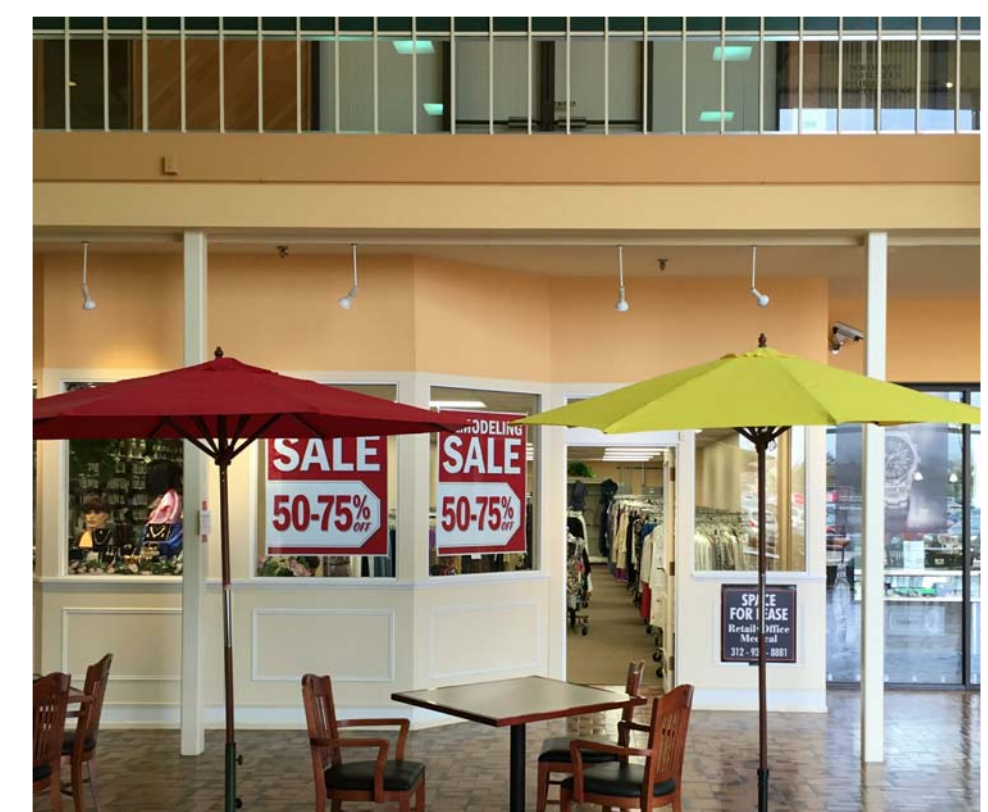
① **ELEVATION (PHOTO)**
1/8" = 1'-0"

NOTE
01) STOREFRONT: WOOD FRAME/GLASS (GOOD CONDITION)

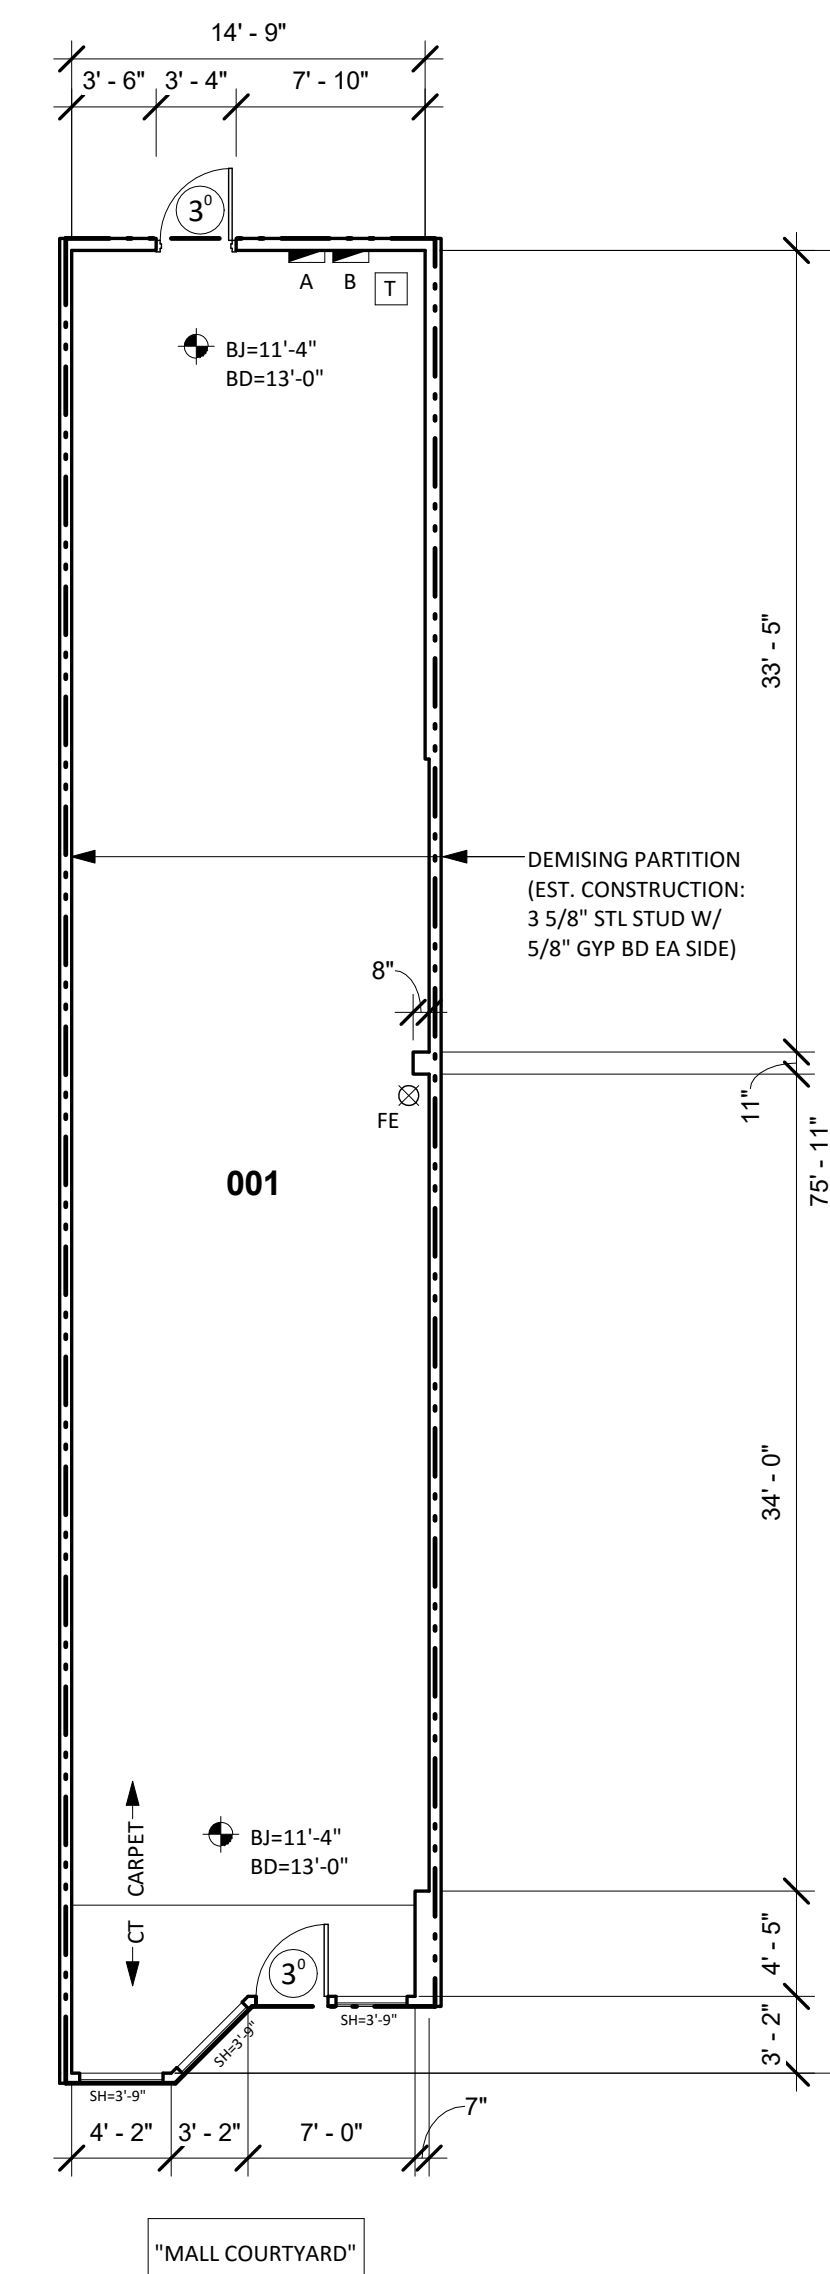
② **EXISTING FLOOR PLAN**
1/8" = 1'-0"

ROOM	FLR MAT'L	FLR CONDITION	WALL MAT'L	WALL COND.	CLG MAT'L	CLG HGT	CLG COND.	ADD'L COMMENTS
001	CARPET	GOOD	WALLBOARD (PTD)	GOOD	ACT	8'-5"	GOOD	4" RUBBER BASE
