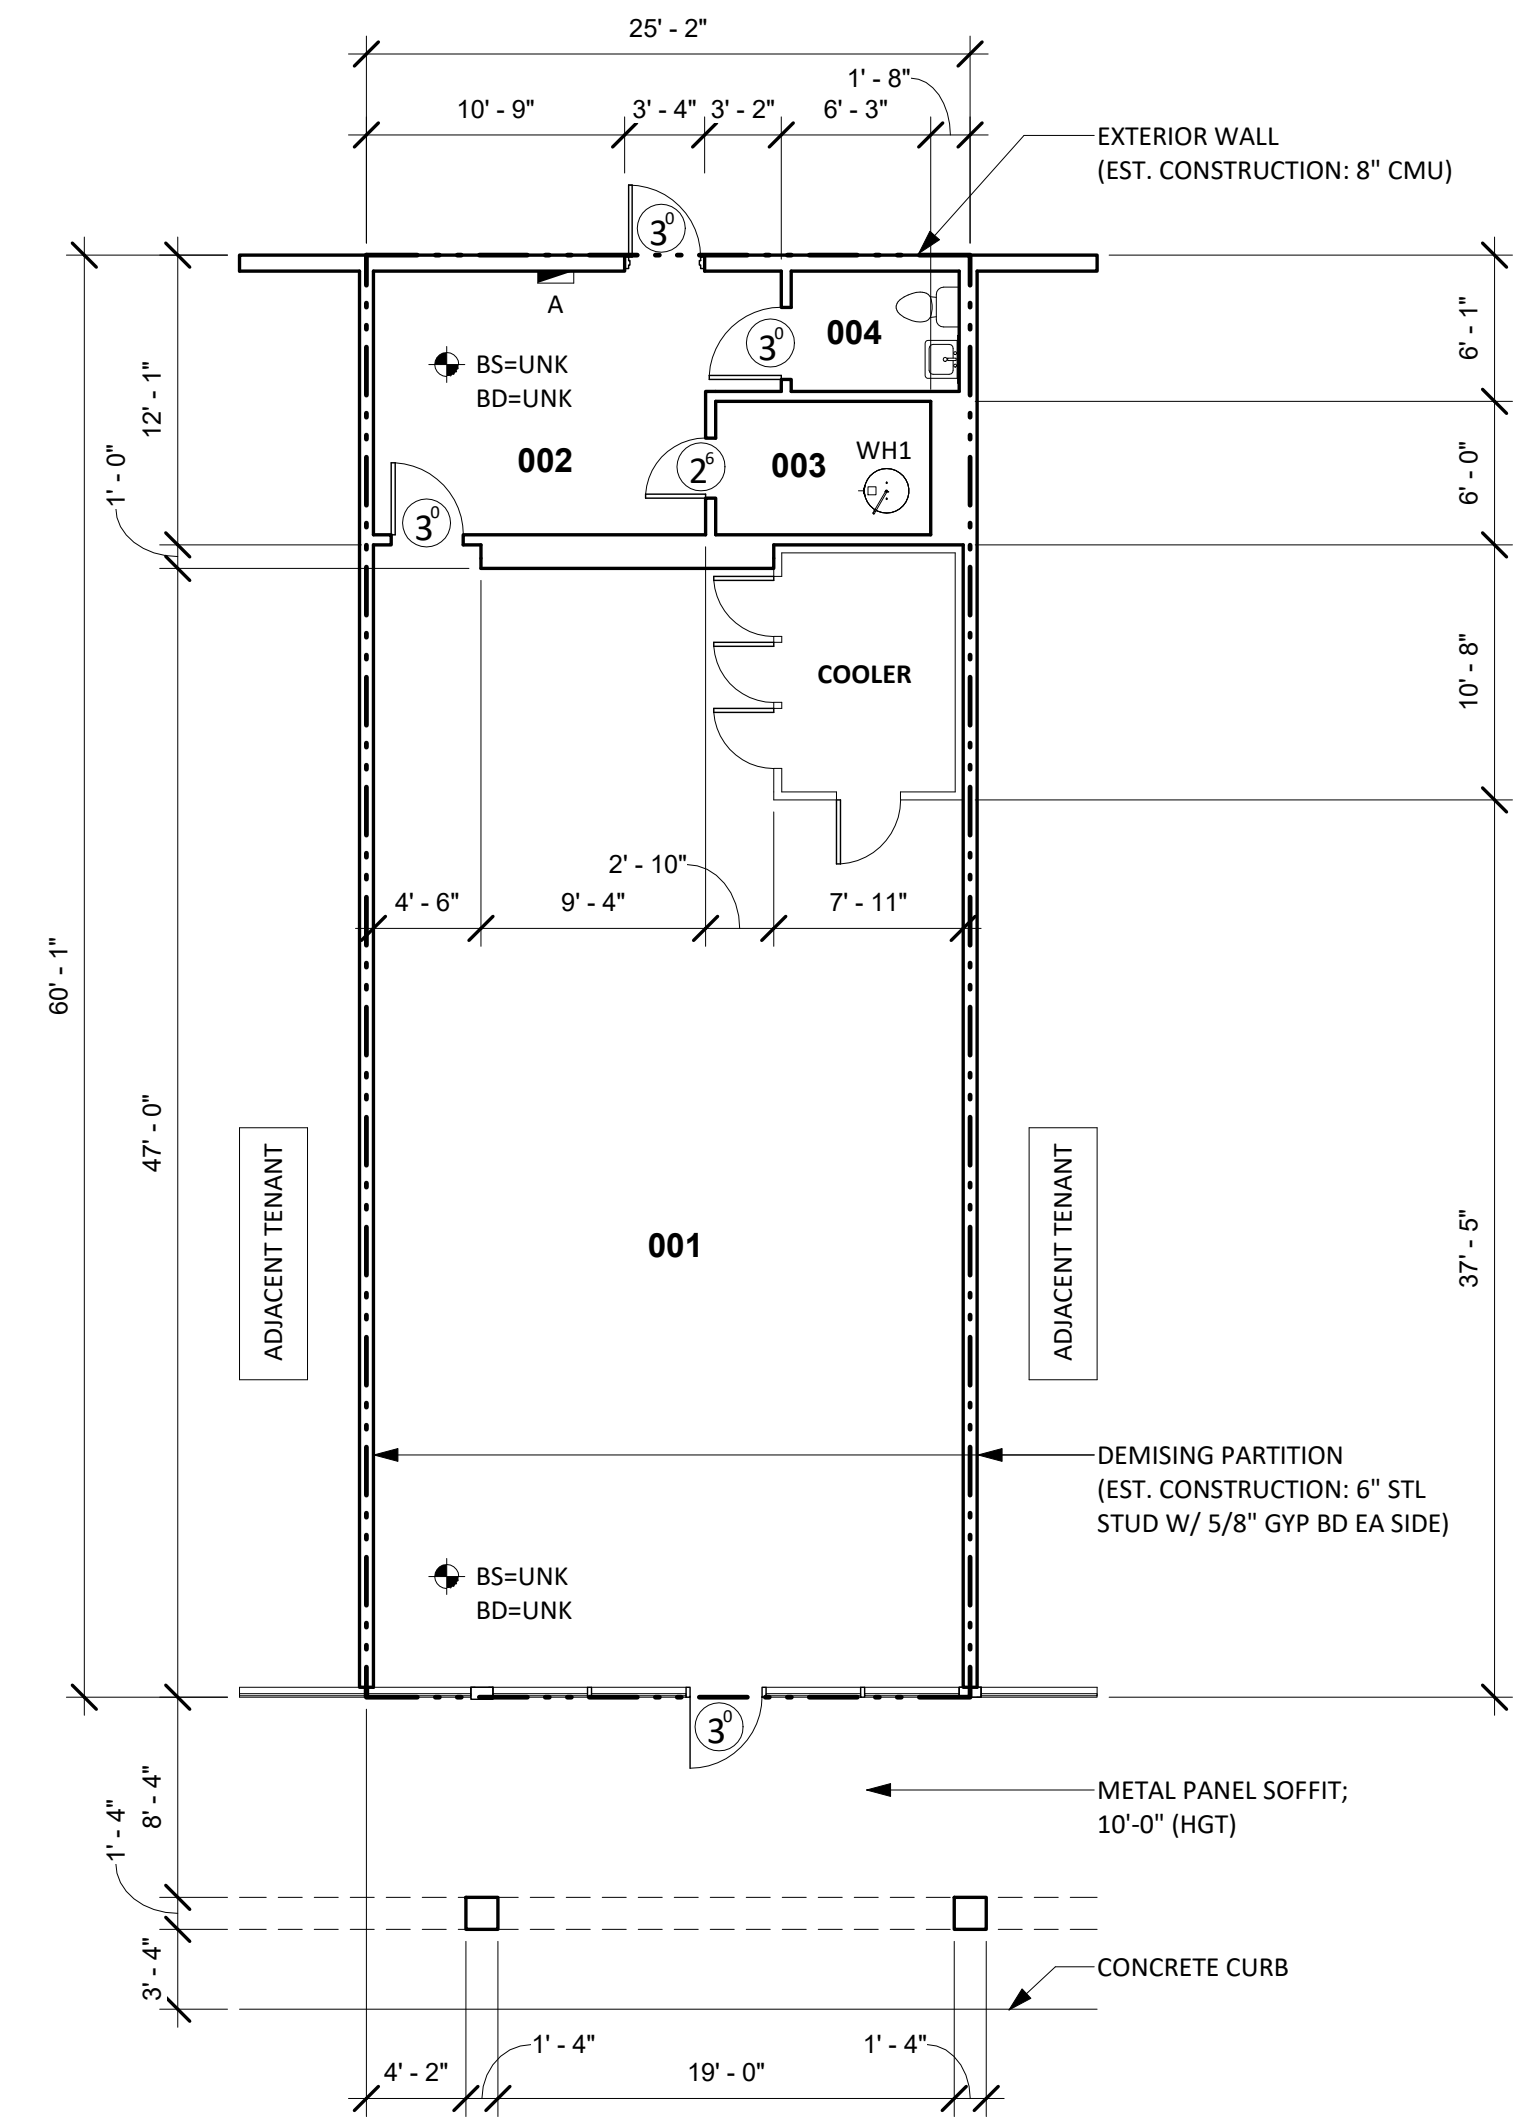
4 EXISTING FLOOR PLAN
1/8" = 1'-0"

ROOM	FLR MAT'L	FLR COND.	BASE	WALL MAT'L	WALL COND.	CLG MAT'L	CLG HGT	CLG COND.	ADD'L COMMENTS
001	VINYL	GOOD	4" RUBBER	GYP BD (PTD)	GOOD	ACT	10'-0"	GOOD	
002	VINYL	FAIR	4" RUBBER	GYP BD (PTD) / CMU (PTD)	GOOD	ACT	10'-0"	FAIR	
003	VINYL	FAIR	4" RUBBER	GYP BD (PTD) / CMU (PTD)	GOOD	ACT	10'-0"	FAIR	
004	VCT	GOOD	4" RUBBER	GYP BD (PTD) / CMU (PTD)	GOOD	ACT	8'-0"	GOOD

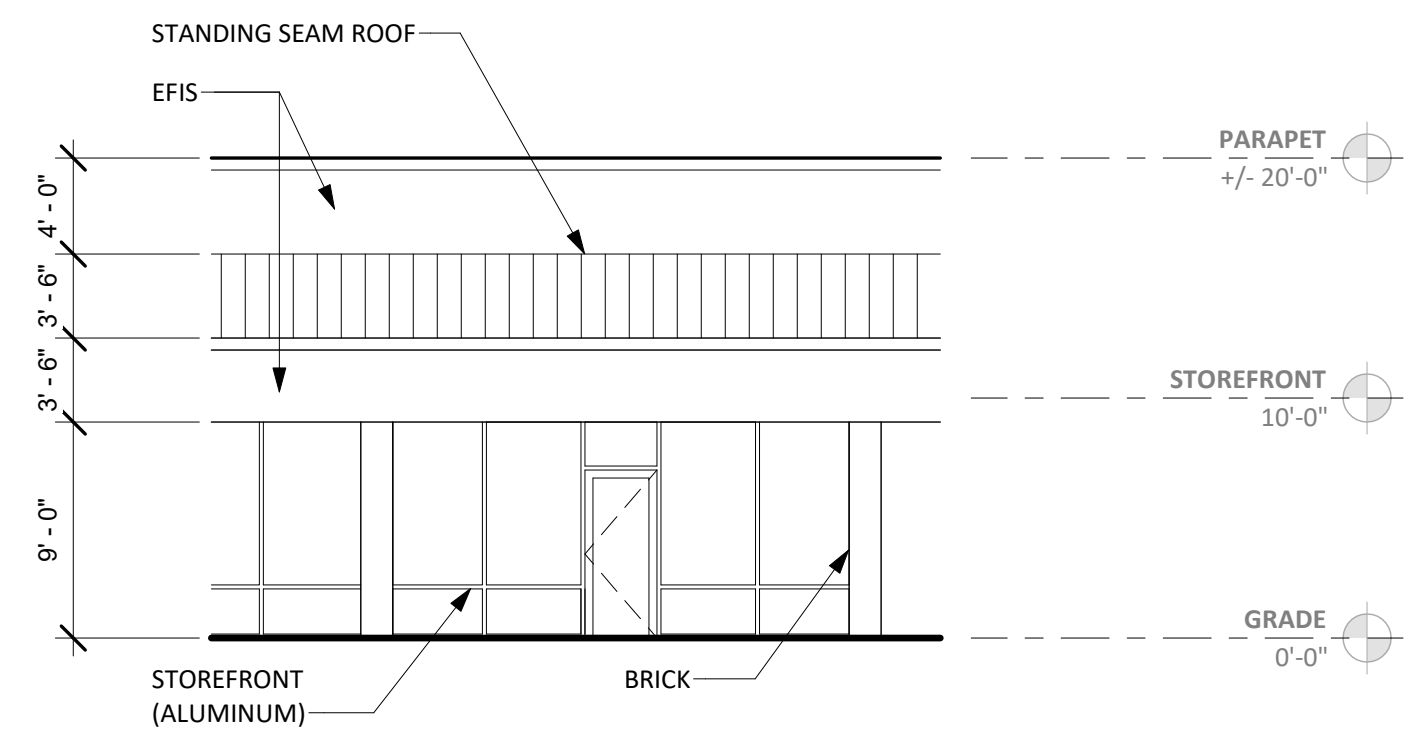
3 FRONT ELEVATION
1/8" = 1'-0"

NOTE
01) STOREFRONT: DARK BRONZE/GLASS (GOOD CONDITION)

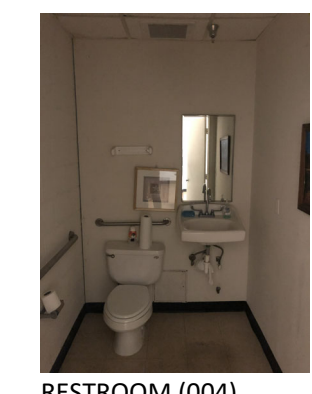
1 RESTROOM COMPLIANCE (PHOTOS)
NOT TO SCALE

GENERAL INFORMATION:
NO. OF LEVELS: 1
BUILDING HEIGHT: +/- 20'-0" (TOP OF PARAPET)
RESTROOM (ADA) COMPLIANCE: NON-COMPLIANT
*REFER TO LOD SUPPLEMENT

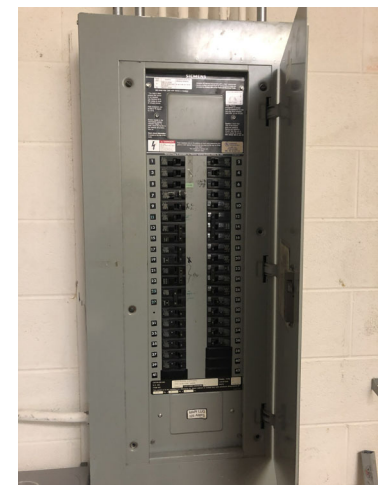
COMPONENT	MANUFACTURE	CATALOG NO.	VOLTAGE	AMPS	PHASING	CIRCUITS	COMMENTS
PANEL A	SEIMENS	S1C42ML125AB5	208Y/120	250	3PH/4W	38 USED
