PHILLIPS EDISON & COMPANY

Existing Conditions for:

5476 Southfield Center

Existing Plan EXI

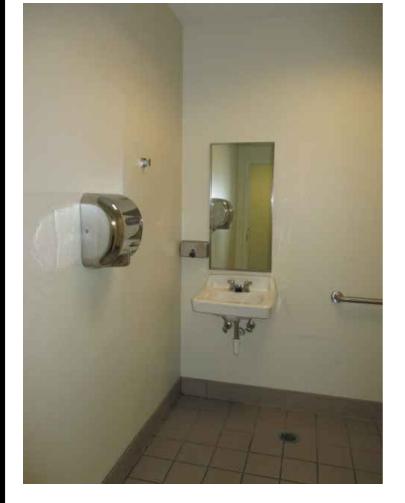
Men's Restroom

Complies with the addition of vertical grab bars at toilets. RESTROOM (ADA) COMPLIANCE:

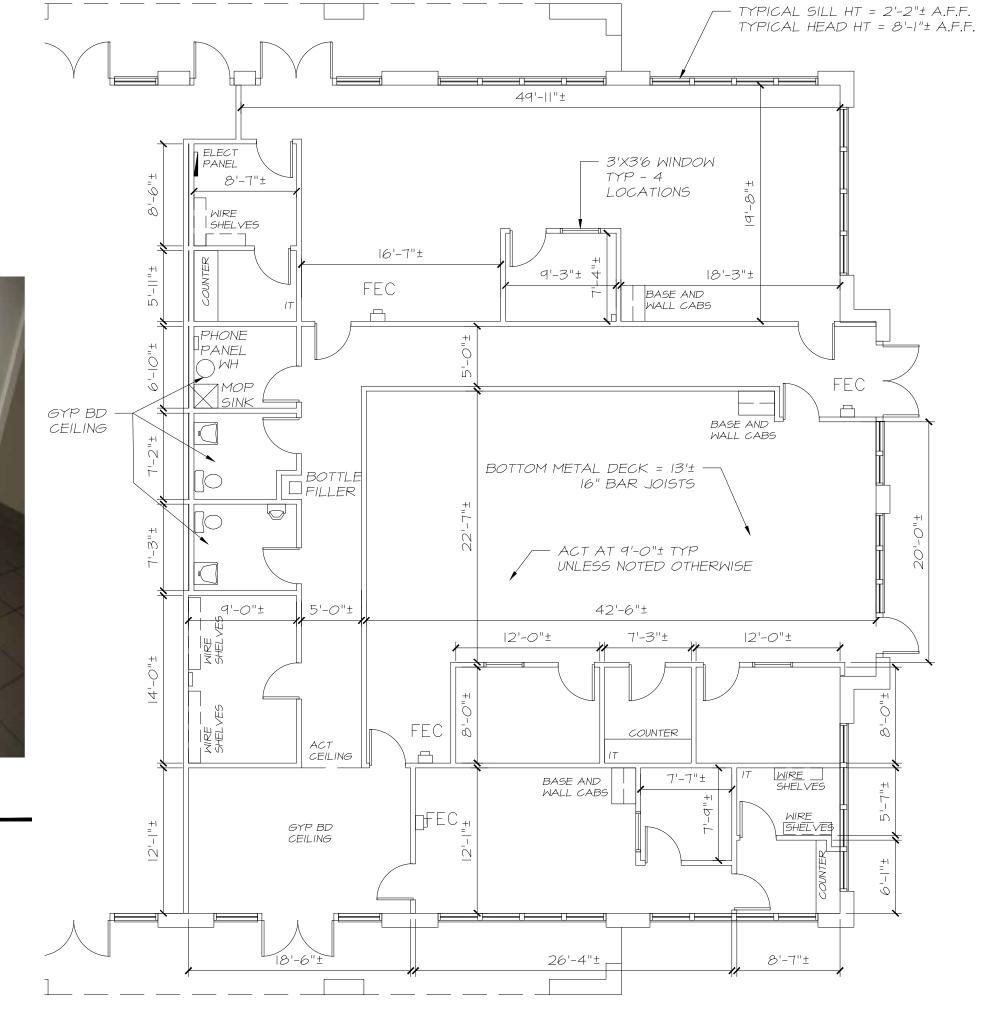
Existing Floor Plan

.. WOOD WINDOWS - NEED SOME MAINTENANCE WORK ON EXTERIOR.
2. FLOORING IS CARPET AND VCT WITH VINYL BASE. BATHROOM IS QUARRY TILE WITH

3. CEILING ARE ACT AND GYP BOARD AT 9'-0"± A.F.F. 4. DOORS ARE 3' X 6'-8" 6 PANEL WOOD DOORS IN HM FRAMES
